Section Inspection - 28/05/2018 - LINE 1

Date of inspection 28/05/2018	Time of inspection 4:29 AM	Asset owner Council	Pipe Asset Id LINE 1	Nr. 1
Project name 2018_05_23	Contract No.	Coding Standard	Name of operator Operator	Job Number

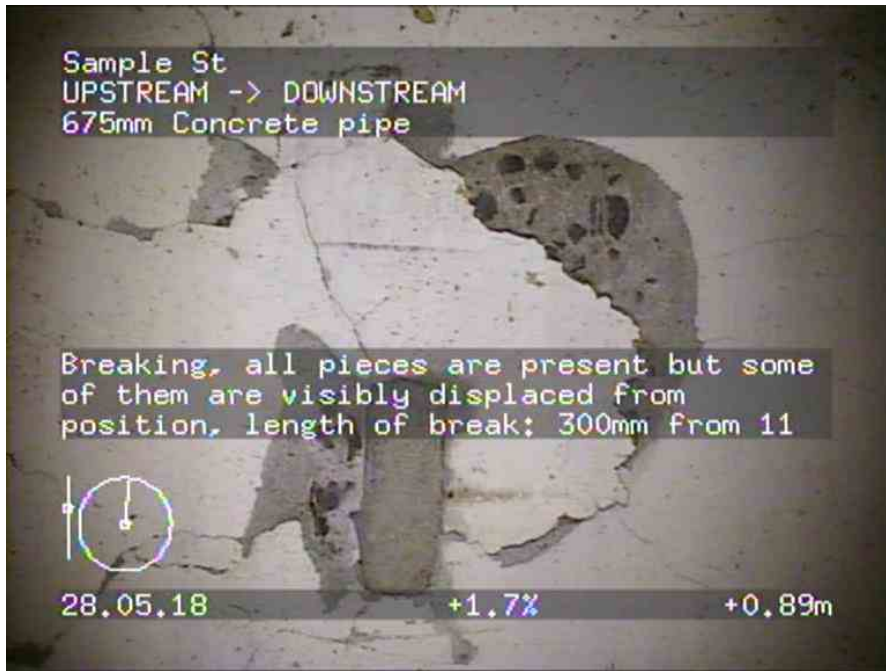
1:175	[m]	Code	Observation Text	Grade	
	0.71	STMH	Start node, maintenance hole, Nodename:., UPSTREAM		
	0.89	BD	Breaking, all pieces are present but some of them are visibly displaced from position, length of break: 300mm from 11 o'clock to 1 o'clock	4	0.89m // 00:00:51.51 //

LINE 1_85427e28-b870-4ad3-9bcc-0ccd0441c95c_20180528_163226_386.jpg, 00:00:51, 0.89
 Breaking, all pieces are present but some of them are visibly displaced from position, length of break: 300mm from 11 o'clock to 1 o'clock

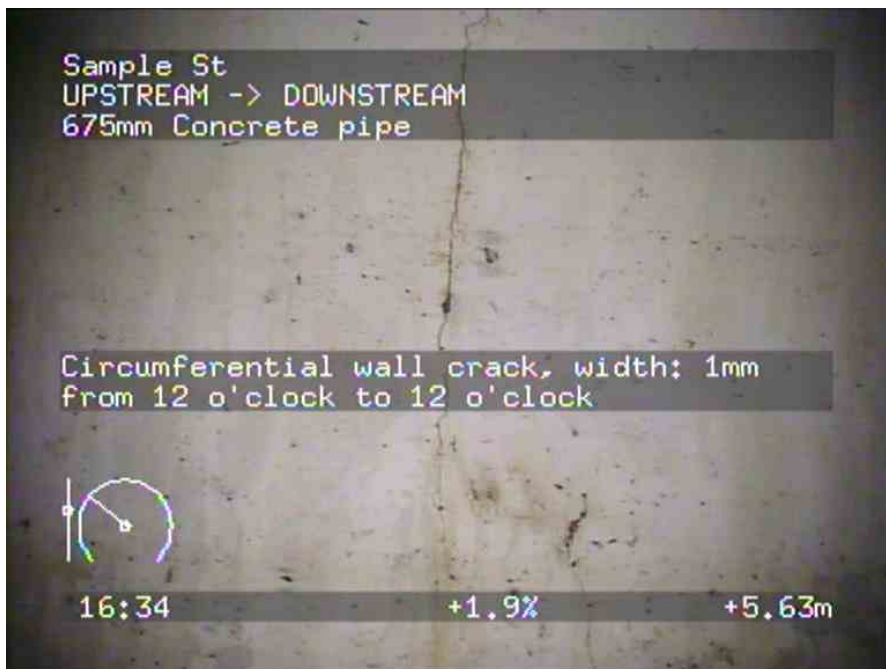
LINE 1_f49dc21d-28f8-49ec-ac90-515583aee087_20180528_163439_706.jpg, 00:02:33, 5.63
 Circumferential wall crack, width: 1mm from 12 o'clock to 12 o'clock

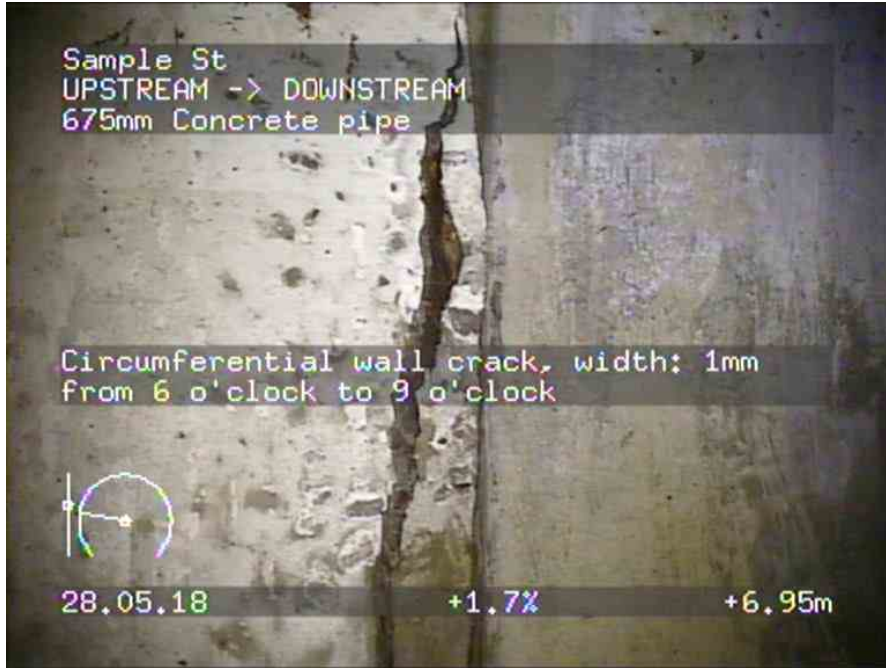
LINE 1_bebc146b-f2ef-45e3-b51c-7c5bde17b2b1_20180528_163535_506.jpg, 00:03:12, 6.95
Circumferential wall crack, width: 1mm from 6 o'clock to 9 o'clock

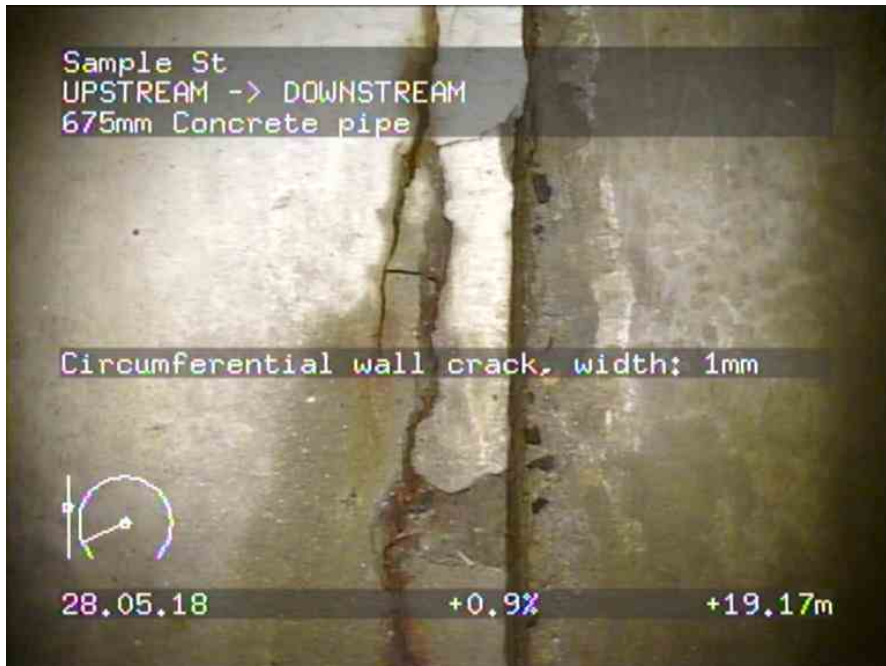
LINE 1_c92a64c4-728d-4ddf-aad3-a19a3c10434b_20180528_163736_514.jpg, 00:04:59, 19.17
Circumferential wall crack, width: 1mm from 6 o'clock to 9 o'clock

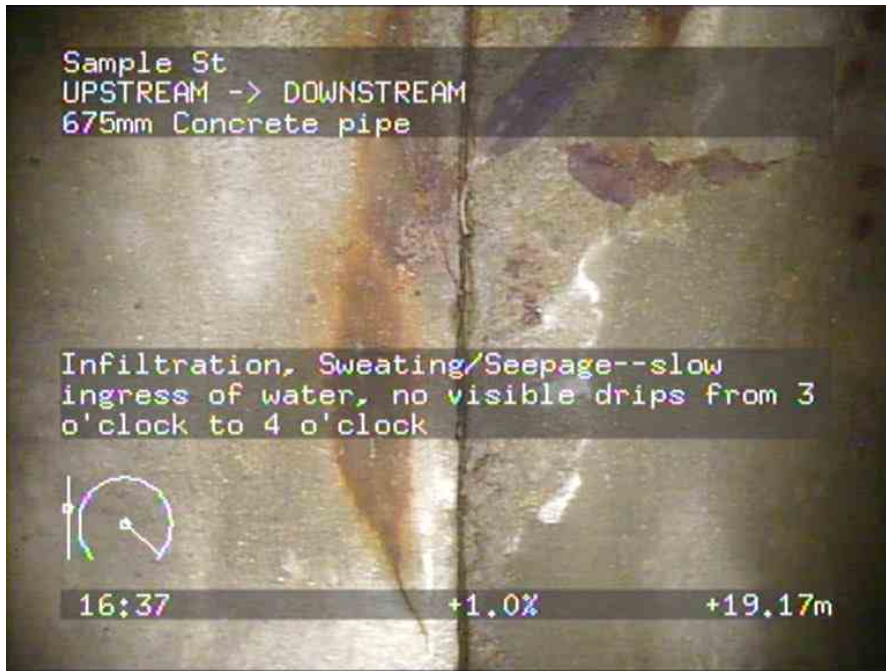
19.17	CCW	Circumferential wall crack, width: 1mm from 6 o'clock to 9 o'clock	1	
	19.17	IS	Infiltration, Sweating/Seepage--slow ingress of water, no visible drips from 3 o'clock to 4 o'clock / 3	1

LINE 1_b914e14c-98b2-46be-b94f-6c1f6bdea3e9_20180528_163804_149.jpg, 00:05:16, 19.17
Infiltration, Sweating/Seepage--slow ingress of water, no visible drips from 3 o'clock to 4 o'clock
