Conduit Inspection

Date: 16/12/2017	Asset owner's job ref.:	Asset Owner:	Operator :	Section number: 20	Pipe Asset Id:
Time of inspection: 08:48:53	Cleaning: Not Cleaned	Standard: WSA 05-2008 2.2	LRP Ins	Conduit Unit Length	Method of Inspection Television Camera

Purpose of inspection : Routine Inspection	Shape : Circular
Use of Conduit: Sewage	Dia/Height: 150 mm
Type of Conduit: Gravity sewer	Lining:
Lining Method:	Pipe Material: PVC-Plasticised

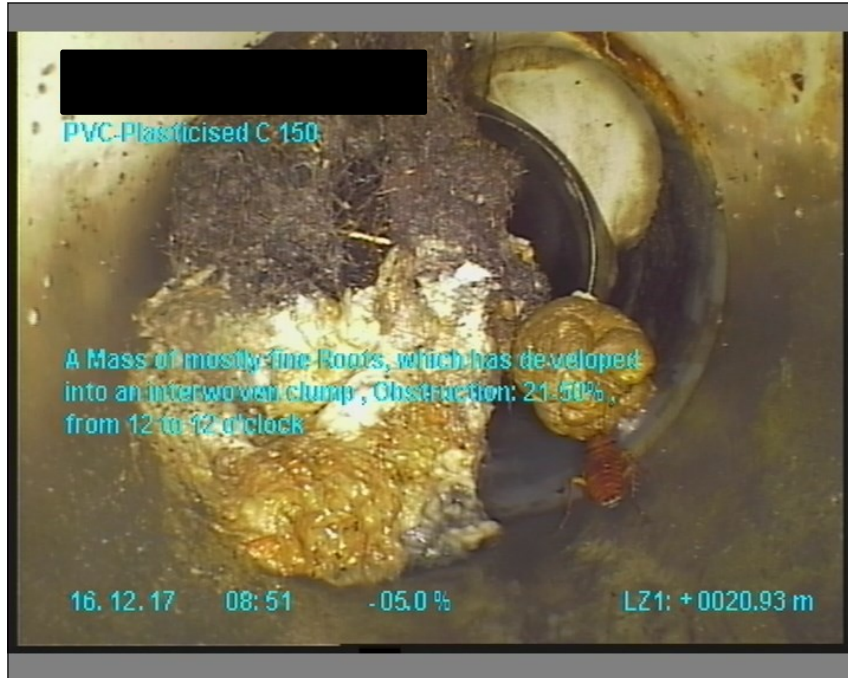
Photo: 085154_16122017_20.JPG
 20.9m, A Mass of mostly fine Roots, which has developed into an interwoven clump ,
 Obstruction: 21-50% , from 12 to 12 o'clock

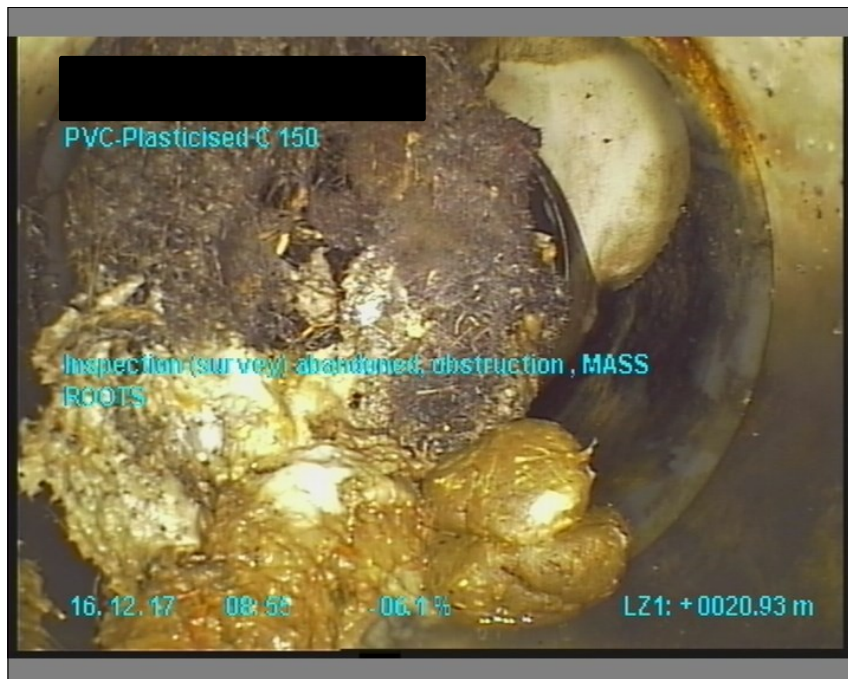
1:165	Position	Observation	Photo
		<p>Start node, maintenance hole, Nodename:</p> <p><u>0.70</u> S1 Deposits on the wall, grease, Reduction in the cross sectional area , Obstruction: <5% , from 12 to 12 o'clock, Start</p> <p><u>0.70</u> Water level, turbid or discoloured flow, depth 5%</p> <p><u>20.90</u> A Mass of mostly fine Roots, which has developed into an interwoven clump , Obstruction: 21-50% , from 12 to 12 o'clock</p> <p><u>20.90</u> E1 Deposits on the wall, grease, Reduction in the cross sectional area , Obstruction: <5% , from 12 to 12 o'clock, End</p> <p><u>20.90</u> Inspection (survey) abandoned, obstruction , MASS ROOTS</p>	<p>20_4A</p> <p>20_6A</p>

Photo: 085540_16122017_20.JPG
 20.9m, Inspection (survey) abandoned, obstruction , MASS ROOTS
