Section Inspection - 28/05/2018 - LINE 1

Date of inspection 28/05/2018	Time of inspection 4:29 AM	Asset owner Council	Pipe Asset Id LINE 1	Nr. 1
Project name 2018_05_23	Contract No.	Coding Standard	Name of operator Operator	Job Number

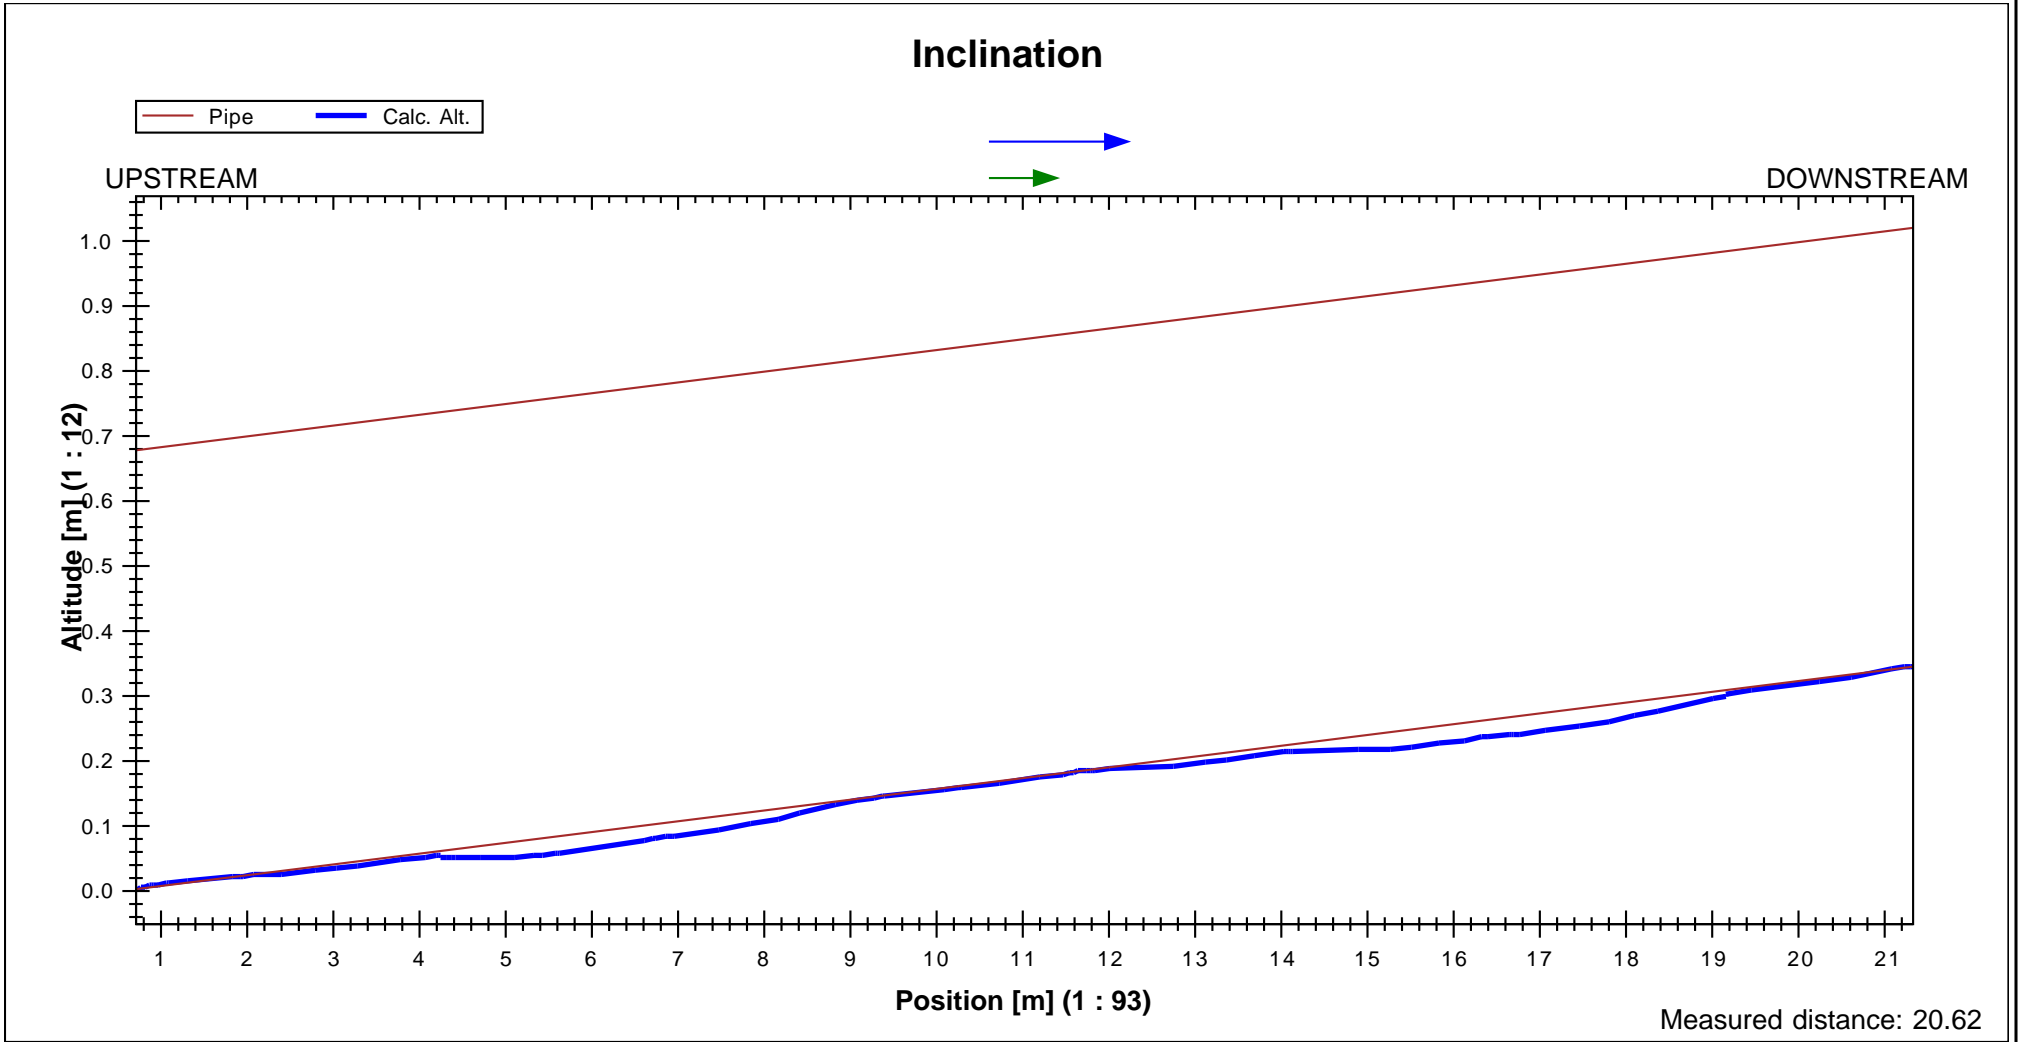
Inclination

Pipe Asset Id	Date of inspection	Time of inspection	Name of operator	Town	US Address/Location	Direction of camera	Inspected Length
LINE 1	28/05/2018	4:29 AM	Operator		Sample St	Downstream	20.62 m
Shape	Dia/Height	Width	US MH	DS MH	Start altitude	End altitude	Measured Inc
	675 mm	675 mm	UPSTREAM	DOWNSTREAM		0.343 m	1.663 m
